DOT/FAA/CT-83/5
DOT/FAA/RD-82/91

Identification of Exit Taxiways (Retroreflective Markers Only)

Prepared By
FAA Technical Center
Atlantic City Airport, N.J. 08405

April 1983

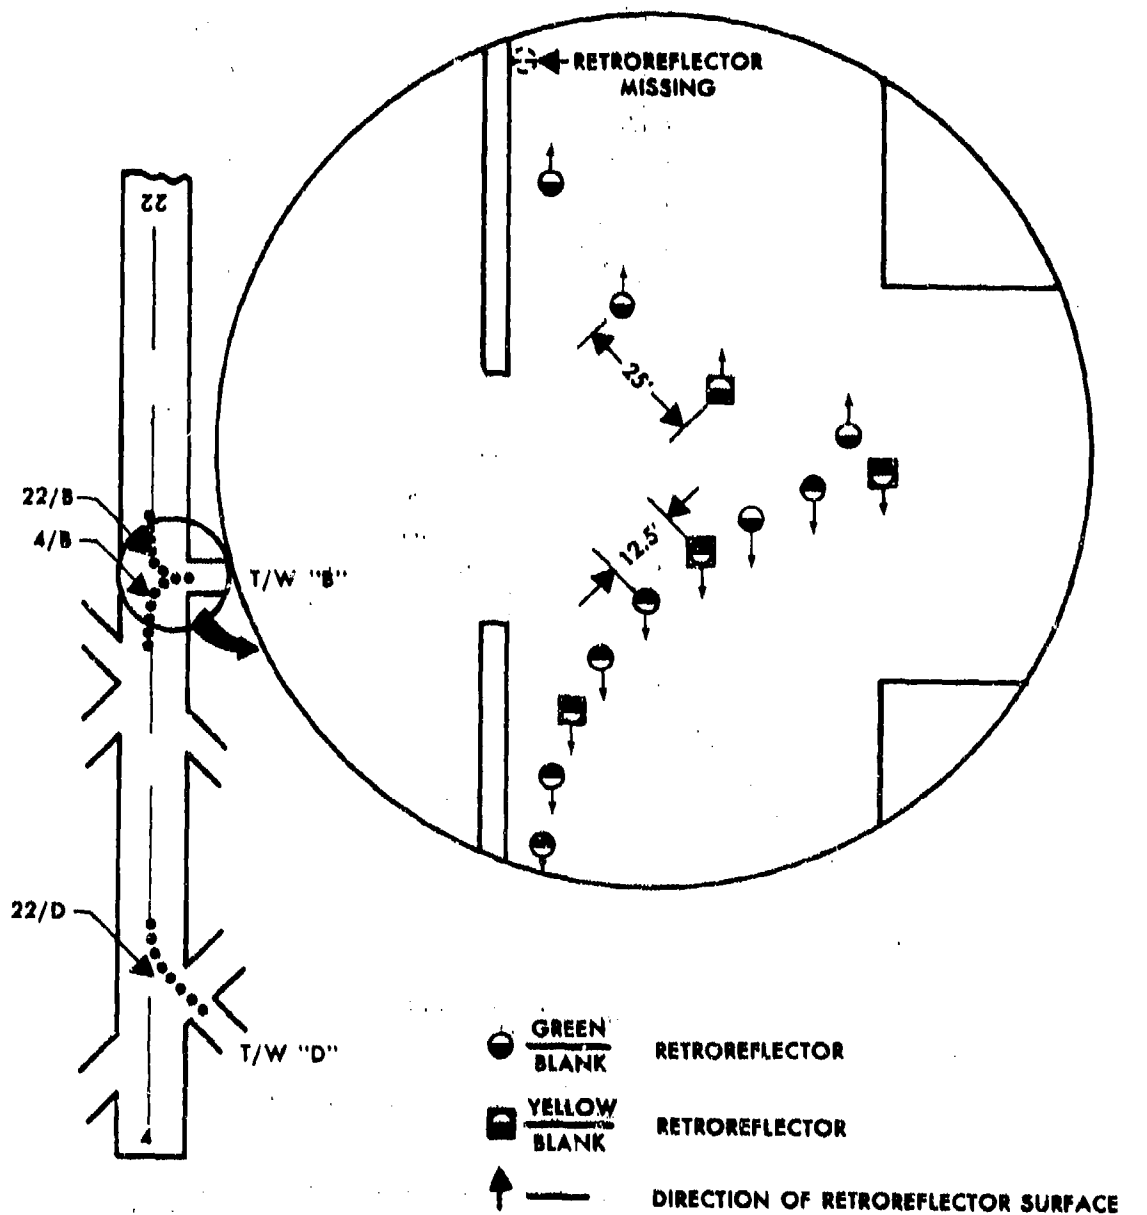
83-5-1

FIGURE 1. RETROREFLECTOR CONFIGURATION AT ATLANTIC CITY AIRPORT
(ACY) ATLANTIC CITY, NEW JERSEY

Retroreflective markers were installed on runway 4/22 at the FAA Technical Center's Atlantic City Airport (ACY). Runway 22 exits identified were Delta and Bravo (22/D and 22/B). Runway 4 had only Bravo exit identified (4/B). For taxiway 4/B 12.5 foot (4 meter) spacing of the retroreflectors was applied along the arc while 25 foot (8 meter) spacing was used for the other exits (figure 1).

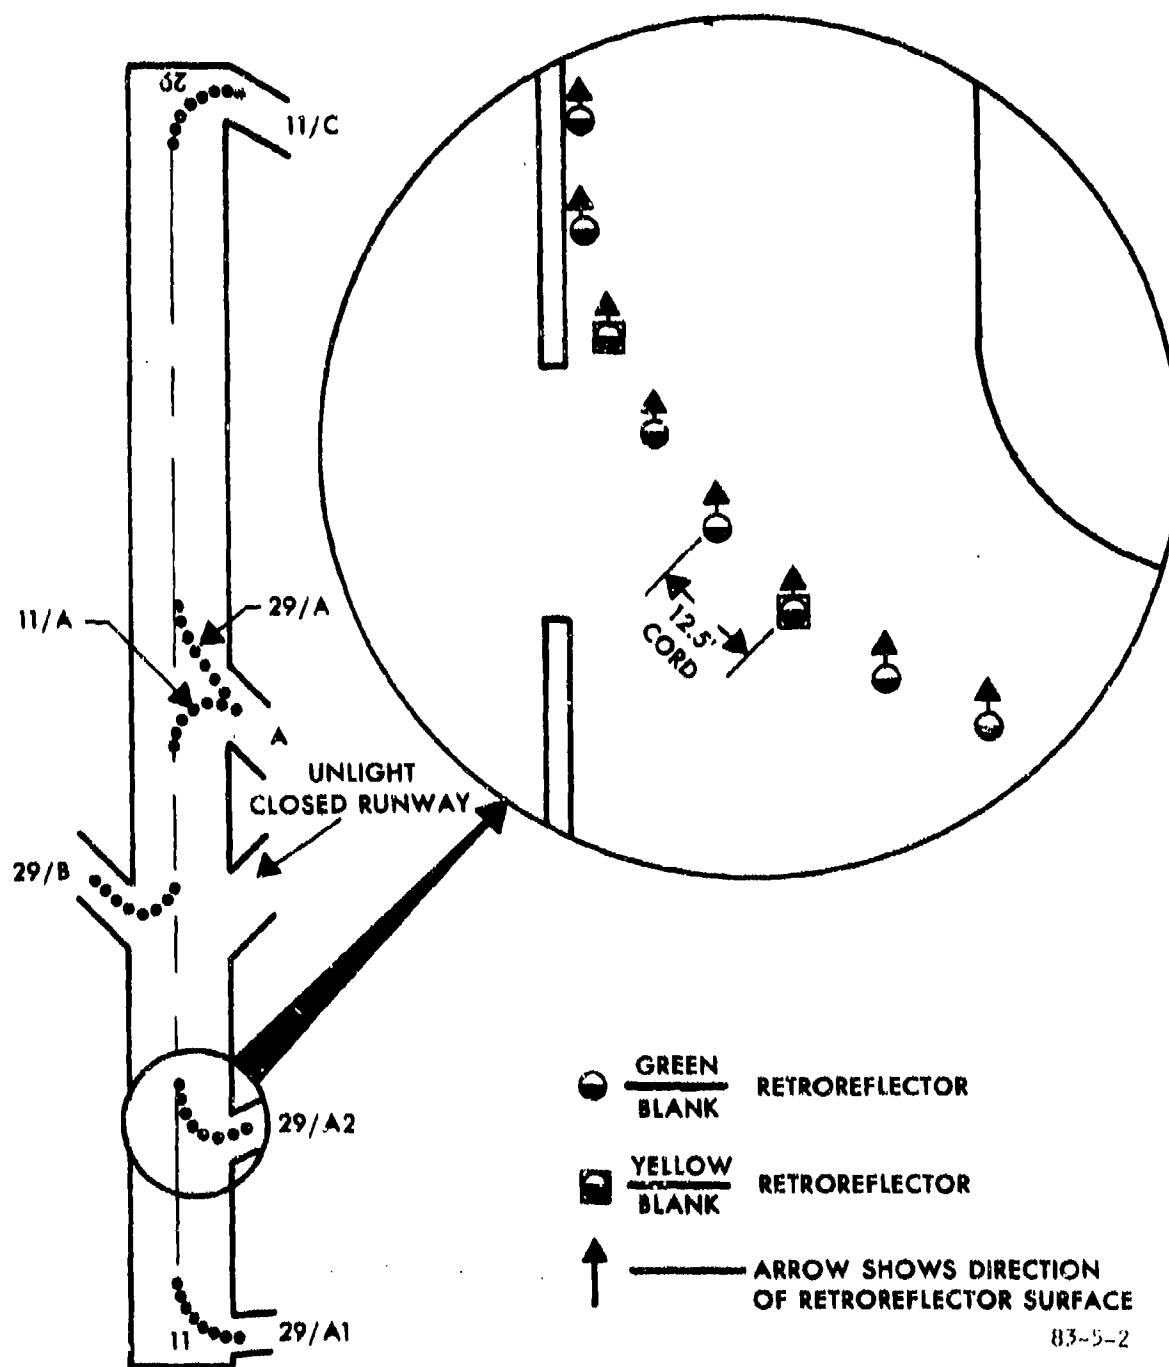
FIGURE 2. RETROREFLECTOR CONFIGURATION AT ATLANTIC CITY/MUNICIPAL/BADER FIELD (AIY), ATLANTIC CITY, NEW JERSEY

The retroreflective markers were installed with 12.5 foot (4 meter) spacing on runway 11/29 at Bader Field in Atlantic City, N.J. Six exit taxiways were marked with the retroreflectors. Two were marked on runway 11 (11/A and 11/C) and four were marked on runway 29 (29/A, 29/B, 29/A2, and 29/A1) (figure 2). Interviews and questionnaires were used to collect data from the Bader Field test.

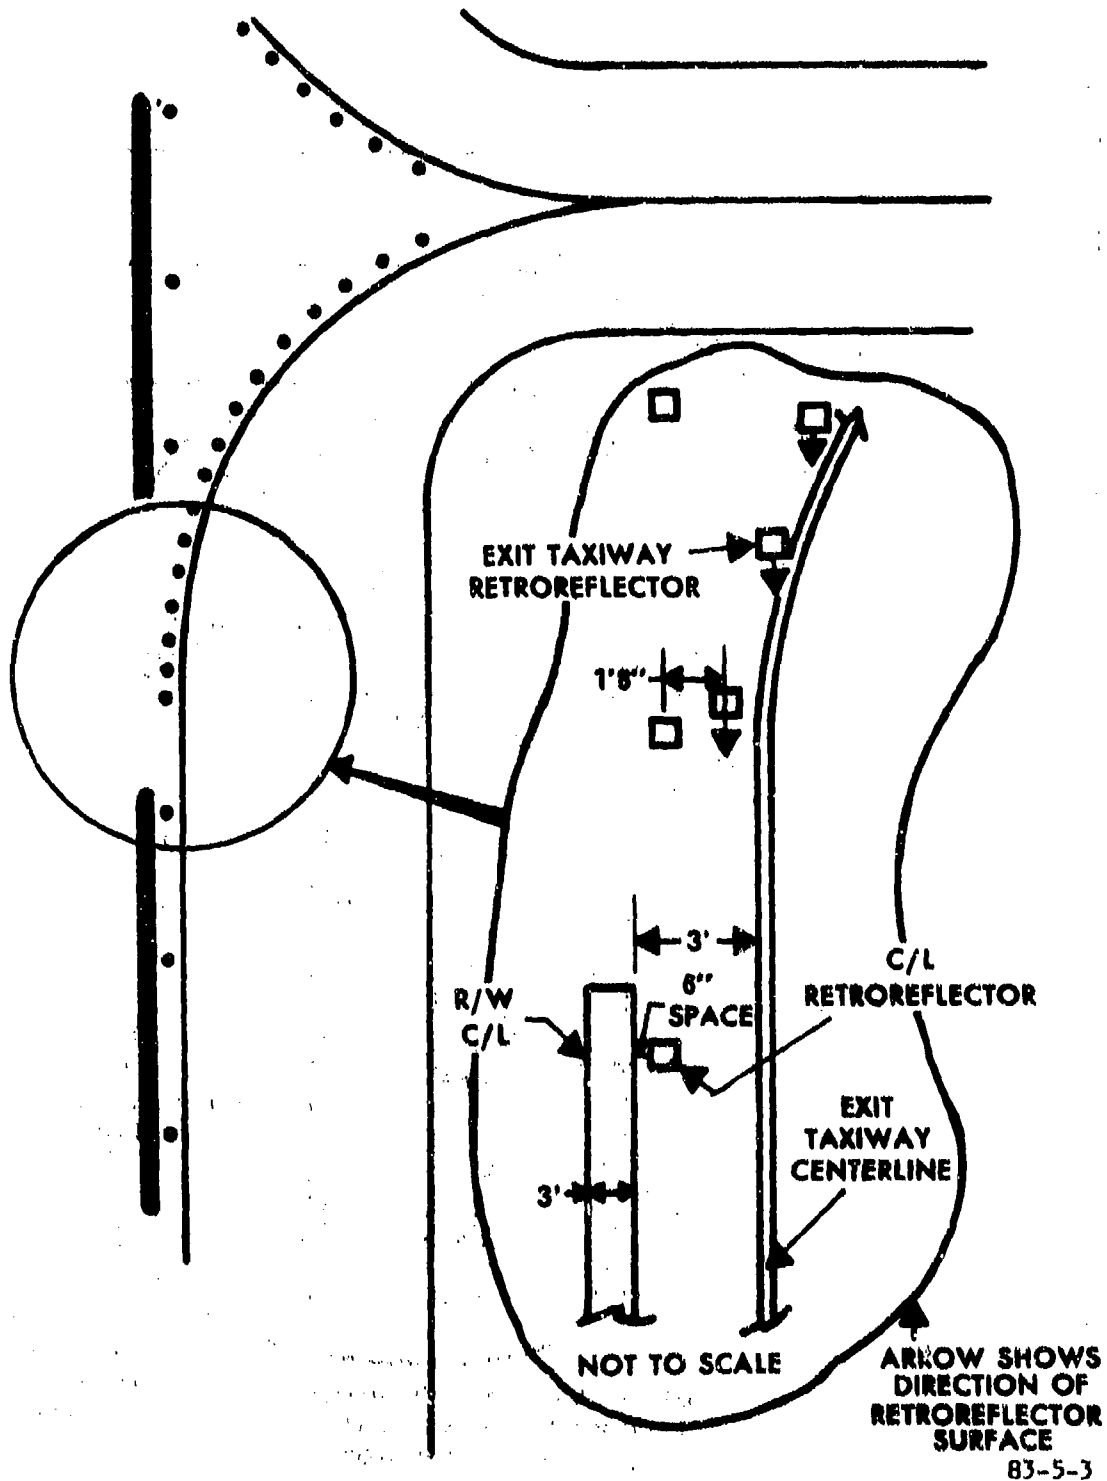
FIGURE 3. LAYOUT OF EXIT TAXIWAY RETROREFLECTORS WITH CENTERLINE RETROREFLECTORS ON SAME SIDE AS EXIT TAXIWAY

The unidirectional retroreflectors should be placed so that they have a cord of 12.5 feet (4 meters) (table 1). The first retroreflector should be located on the arc where it is tangent to the runway centerline. The first exit taxiway retroreflector should be located as close as possible to the centerline of the runway. If runway centerline retroreflectors are used, then the runway centerline retroreflectors should be placed on the side having the most frequently used exits. See figures 3 and 4.

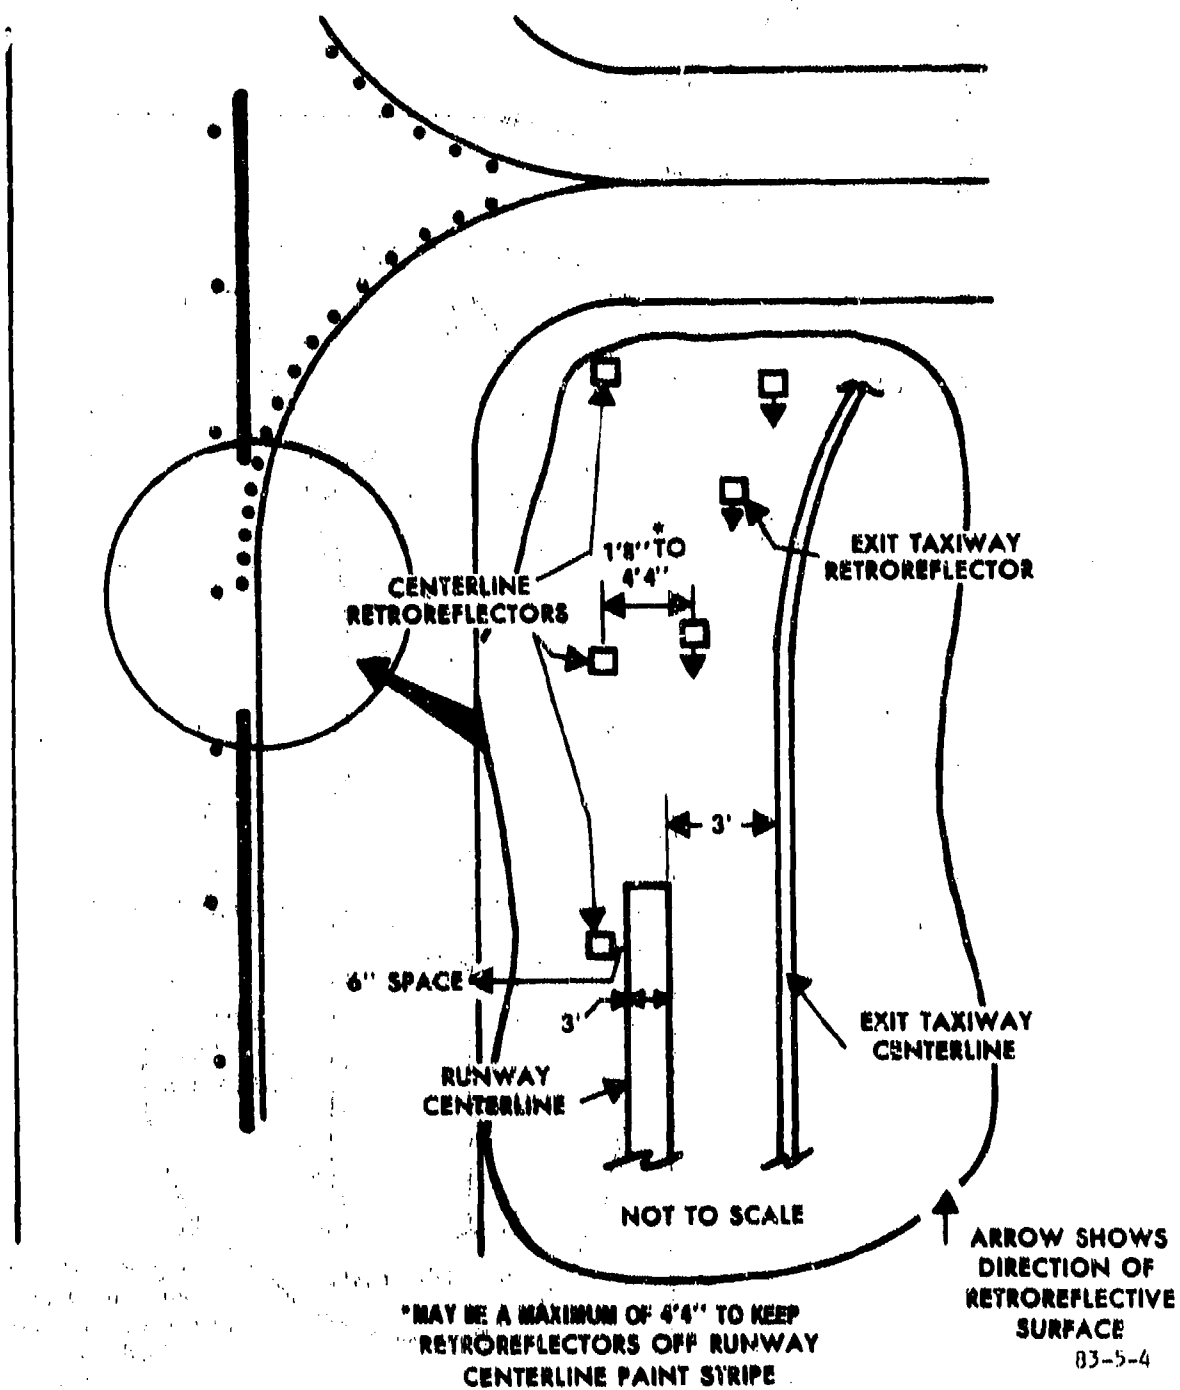
FIGURE 4. LAYOUT OF EXIT TAXIWAY RETROREFLECTORS WITH CENTERLINE RETROREFLECTORS ON OPPOSITE SIDE FROM EXIT TAXIWAY

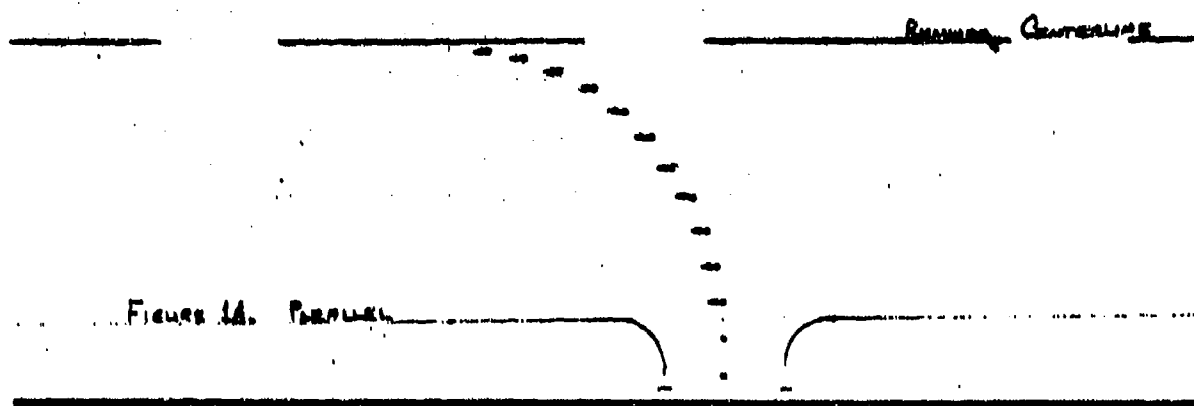
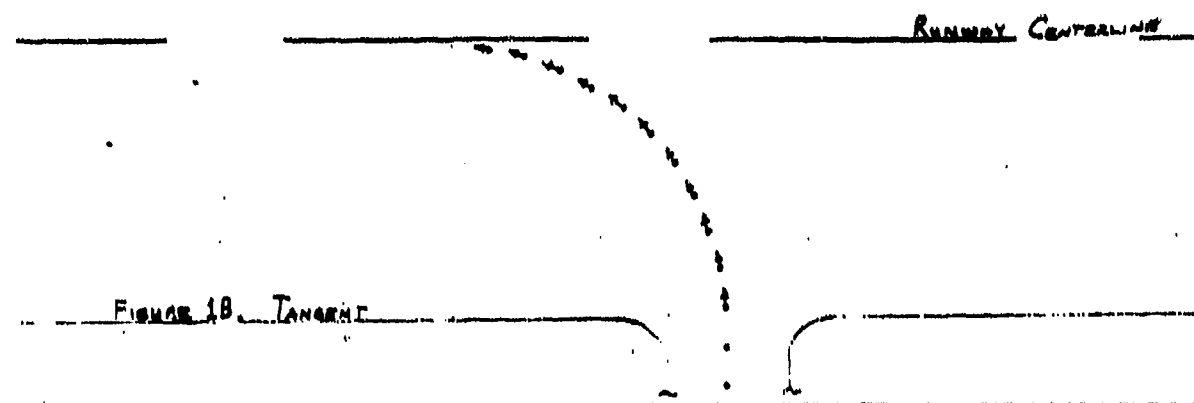
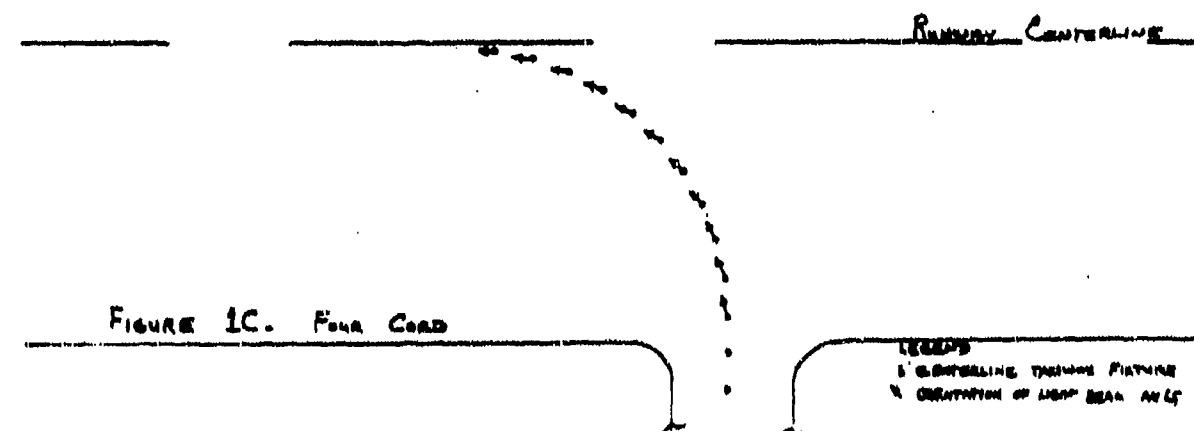
FIGURE 1. EXIT TAXIWAY LIGHT AIMING

1. Parallel to the runway centerline (Figure 1A).
2. Tangent to the exit taxiway centerline curve (Figure 1B).
3. Toed-in to intersect the exit taxiway centerline at a point equal to four times the spacing of the lights (cord) (Figure 1C).
4. Miscellaneous aimings determined by trial and error.

All aiming methods proved to have objectionable characteristics when used with the L-852N fixtures. The tangent and toed-in aiming methods were found to be acceptable when used with the L-852W fixture.
